Large Steel Tank Fails and Rockets to Height of 30 meters - Rupture Disc Installed Incorrectly

Published in:
Safety and Health at Work

Publication date:
2016

**Vertical cylindrical 90 m³
steel tank operated at
"slight overpressure"
rockets to height of 30 m –
rupture disc overpressure
relief device inoperative,
installed upside down**

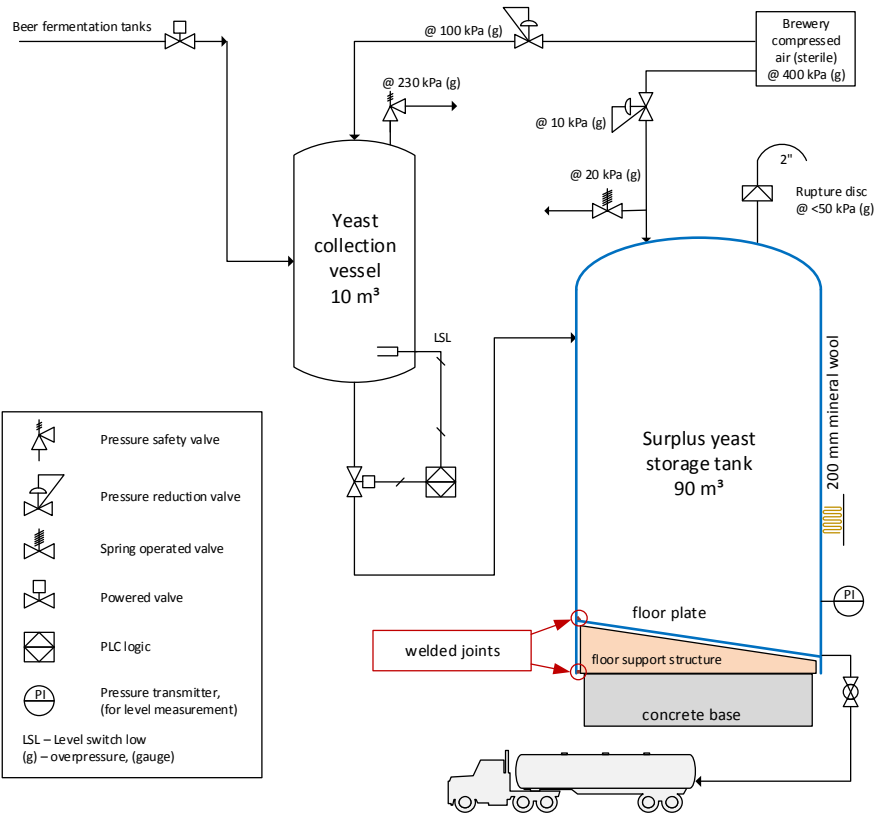
At a Danish brewery, surplus yeast slurry is first collected in an indoor yeast collection vessel and then transferred to an outdoor storage tank (Figure 1).

The indoor yeast collection vessel has a volume of 10 m³ and is connected to the brewery's sterile compressed air system and kept at 100 kPa overpressure. When an operator initiates the transfer of yeast slurry, a bottom outlet valve opens and the compressed air pushes the viscous yeast slurry to the 90m³ outdoor storage tank. The control logic closes the bottom valve when a signal from a liquid level switch low (tuning fork/vibrating fork type) indicates that the vessel is empty.

Figure 1 Schematic representation of surplus yeast system

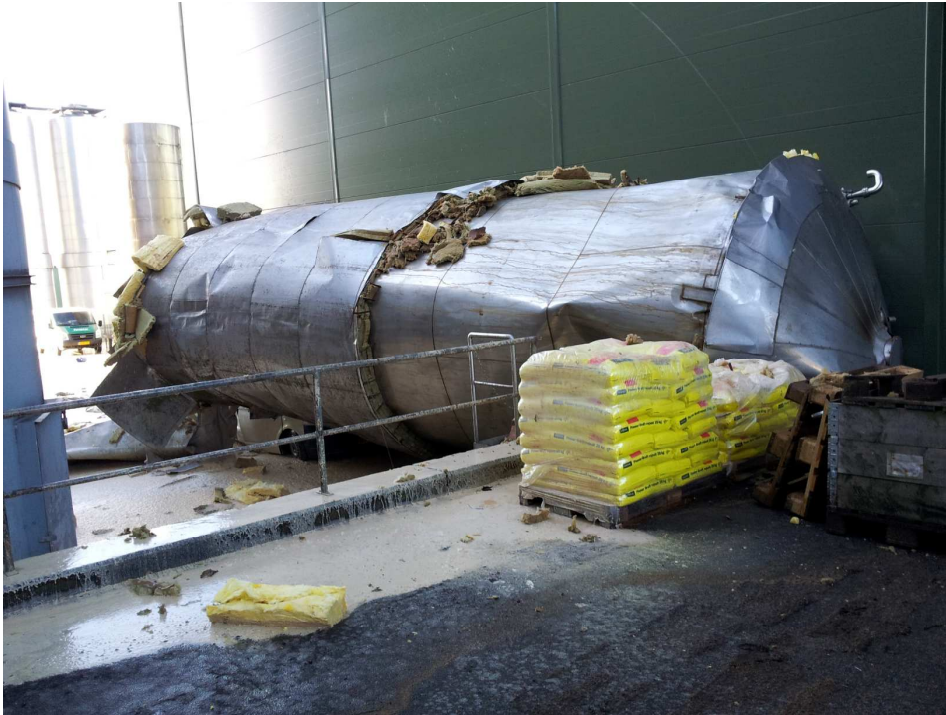
Shortly before the tank failure, two refrigeration technicians employed by an external contractor arrived to service a large ammonia-cooling unit located on the roof of the adjacent building. They parked their van next to the outdoor yeast storage tank, entered the building and climbed the stairs to the roof. Immediately after passing through a doorway in a 3 m tall noise protection wall on the roof they heard a sudden dull *poof* sound. They turned around and saw the storage tank rising vertically up in the air. The base of the tank clearly rose above the roof of the adjacent tall green building, then fell back to the ground landing on their van. They rushed back down and saw that the van had been crushed (Figure 2, Figure 3).

*Figure 2 The van is visible under the tank. Tank contents washed up on elevated platform.
((Photo courtesy of the company))*

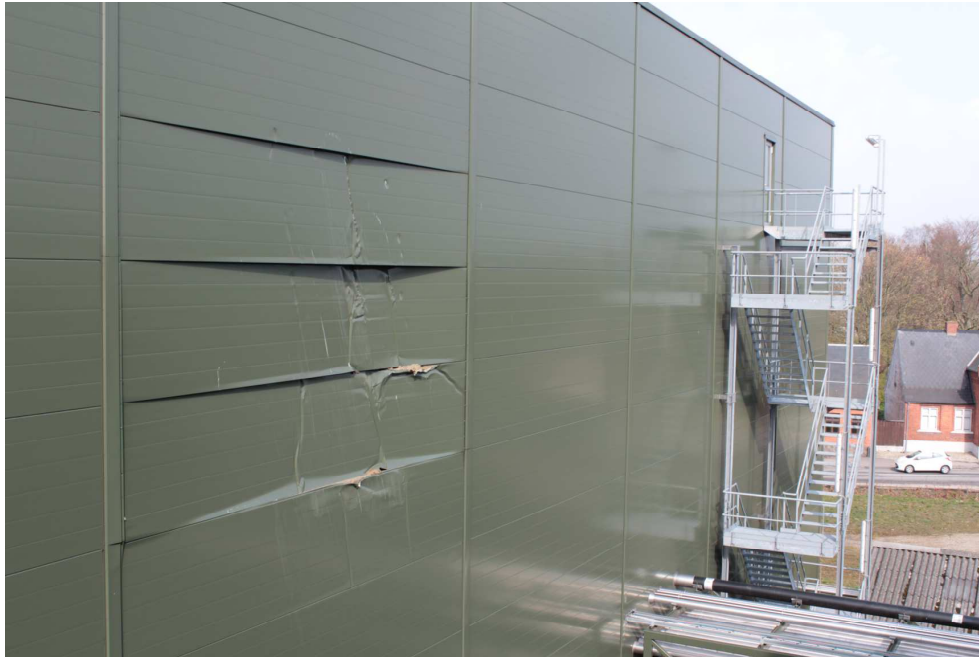
A specialist metallurgy company examined the failed tank, the supports and the welds. The tank shell skirt had been joined to the circumferential steel profile at the base of the supporting steel structure by 58 short welds each distanced about 0.15 m. The short welds were absent in two adjacent arc sections, each about 0.5 m length, which were identified as the probable point of failure initiation. The position of the two arc segments were opposite the tall green building, which would imply that the tank would tilt towards that building immediately before rocketing. This is consistent with impact damage to that building's exterior panels, when the tank descended (Figure 4).

Figure 4 The tank rose almost vertically in the air and the base of the tank rose higher than the 19 m tall green building. Whilst descending, the tank impacted and deformed the building's exterior wall panels (Photo courtesy: Frank H. Hedlund)

The likely failure mechanism is that excess internal overpressure acting on the roof created an uplift force on the shell, which strained the welds and the corroded L-shaped anchors at the base.¹ The welds at the base skirt then failed, resulting in shell uplift. The 3 mm floor plate, which had had little stiffness, then bulged. This led to catastrophic failure of its circumferential weld seam. Immediately after that, the tank's pipe connections were torn off. The tank then lifted off and spilled its contents.

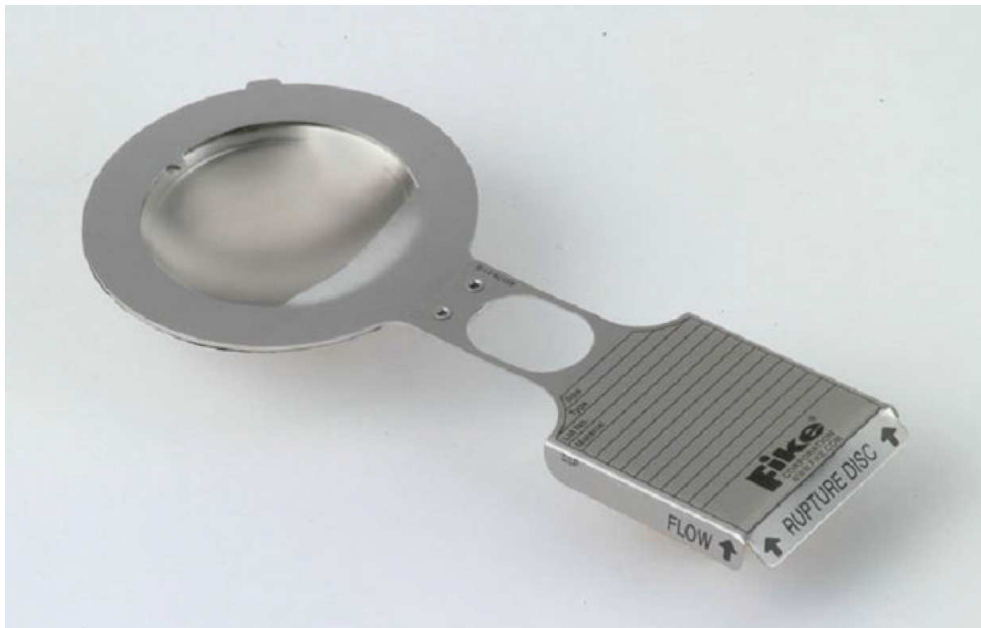
The rupture disc was intact. It was a reverse buckling type device that had been installed upside down (i.e. with the dome facing away from the tank). The vendor stated when asked, that the

rupture disc likely could withstand an overpressure of at least three times the stamped pressure (i.e. 150 kPa or more) before bursting, if installed upside down.

Figure 5 Reverse buckling type rupture disc (dome points towards the fluid pressure) similar to the one installed on the incident storage tank. Proper flow direction of pressure release is marked on the nameplate (Photo courtesy: Fike®)

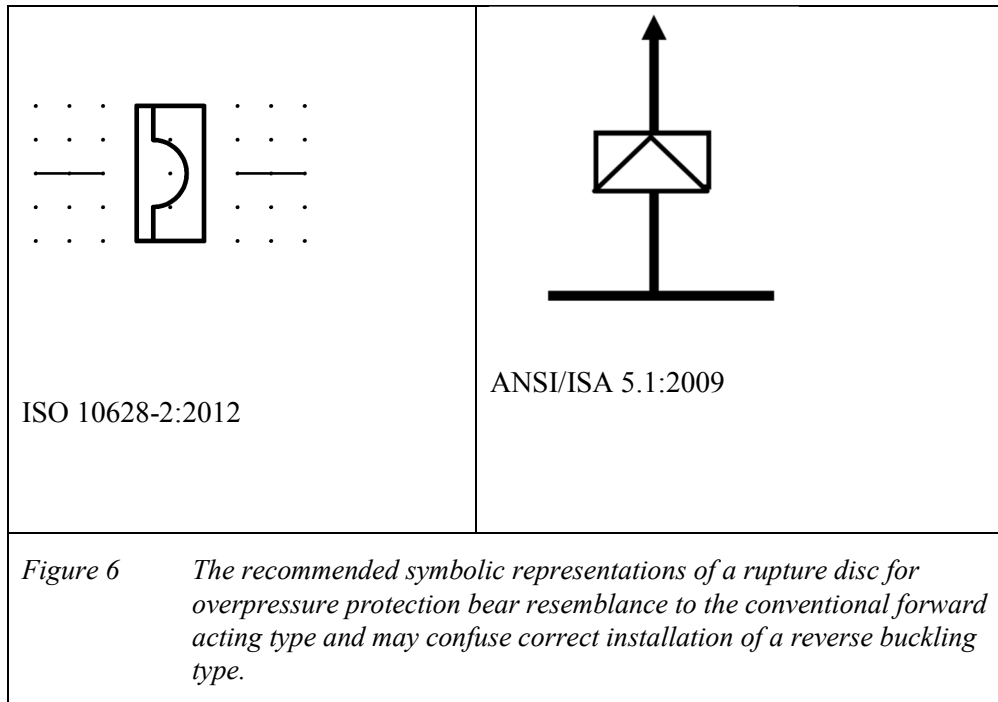
To guide correct installation, arrow marks printed on the nameplate indicate the direction of pressure relief (Figure 6). However, the dome itself can point either way depending on the type of design and gives no reliable indication of the correct direction of installation.

Figure 6 shows the symbolic representation of a rupture disc for piping and instrumentation diagrams (P&IDs) recommended by the ISO 10628 standard [16] and the ANSI/ISA 5.1 standard [17]. Assuming a conventional left-to-right reading direction, the ISO symbol clearly depicts a forward acting disc type and the ISA rectangle symbol may easily be interpreted to do so as well. The installation of a rupture disc requires no specialized training and it may be speculated that the symbols might mislead a less experienced pipe fitter to believe the dome should be installed facing away from the tank. This would result in an upside down installation of a reverse buckling type disc.

As mentioned above the rupture disc on the outdoor storage tank that was installed upside down was precisely a reverse buckling type disc.
